Porcelain Chipping

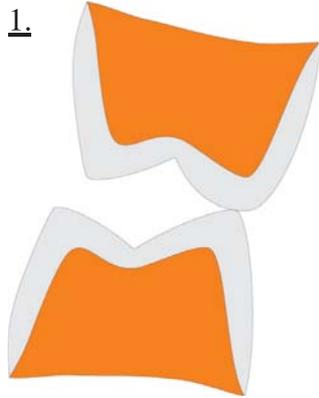
Occlusal high spot in need of adjustment

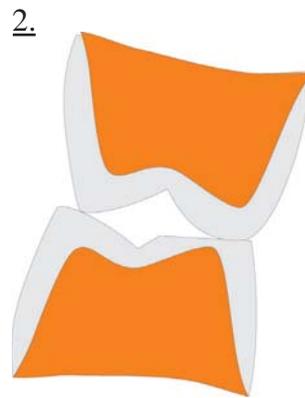
Adjustment carried out

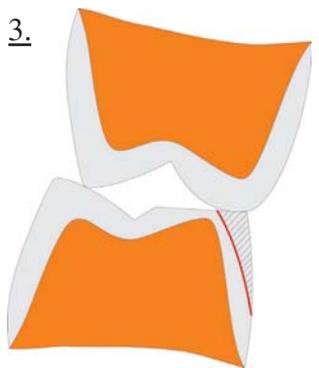
Square edge corner created by adjustment poses risk of chipping

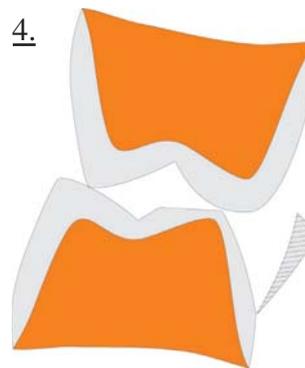
Veneer porcelain chipping is most frequently caused by inadequate finish following occlusal adjustments as illustrated below:

Part of veneer porcelain flakes off

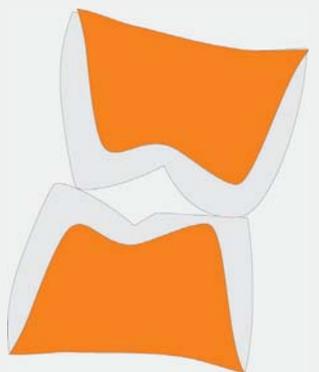
Adjustment carried out
